FIG. 26.—CASTLEWOOD DAM, COLORADO; PLAN, SECTIONS, AND ELEVATION.

**Pecos Valley Rock-fill Dams, New Mexico.**—Two rock-fill dams with earth facings have been constructed across the Pecos River, in the Pecos Valley, New Mexico, which have boldly and successfully exemplified a distinct type of dam that is considered to be preferable to all other rock-fills where the proper conditions exist and suitable materials are obtainable. One of these dams is located 6 miles and the other 15 miles above the town of Carlsbad, N. M. They were built by the Pecos Irrigation and Improvement Company.

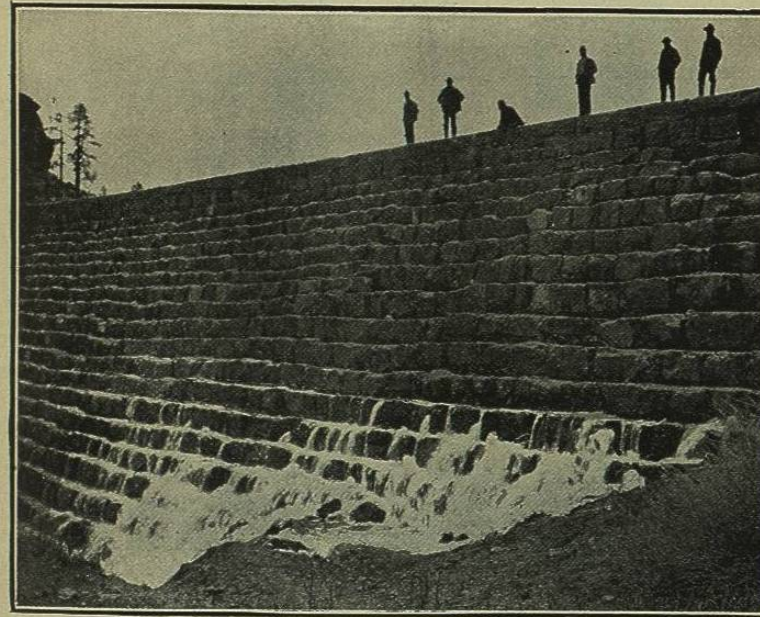
FIG. 30.—CASTLEWOOD DAM, COLO., SHOWING LEAKAGE THROUGH ROCK-FILL.

spillway at the side, while the discharge pipes were wide open. At the same time a large volume of water found its way through the cracks in the masonry wall, and poured out in large streams through the rock-fill for 10 to 15 feet above the base.

The photograph, Fig. 30, shows an enormous amount of this leakage, and the cause for the alarm created in Denver, which lies directly in the path of the escaping water. That the dam was able to withstand such a volume of leakage is a testimonial to the stability of rock-fill dams, which in this case afforded such complete drainage as to be unaffected by leakage that would immediately have destroyed an all-earth dam.

Subsequently repairs were made in the manner illustrated by Fig. 31, taken from *Engineering Record*.

An earth embankment, 8 feet wide on the crest, was built on the up-stream side to the full height of the rock-fill, with slope of 3 on 1,

faced with 12 inches of riprap. Underneath this embankment the outlet pipe was extended from the valve chamber to the up-stream toe by building a 40-inch woodstave pipe, surrounded with reinforced concrete 1 foot thick. This pipe connects with a steel box encased in concrete, into which all of the eight 12-inch pipes that pass through the masonry make connection.

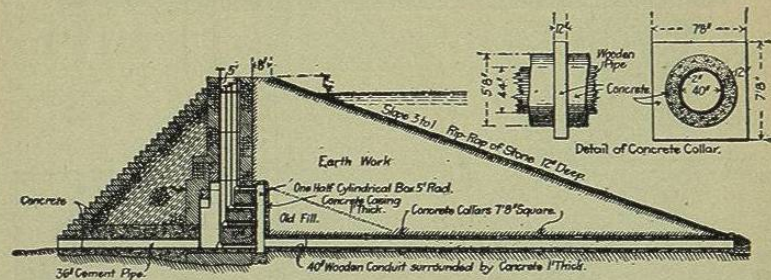
FIG. 31.—CASTLEWOOD DAM, COLO. SECTION AFTER RECONSTRUCTION.

The 40-foot spillway, which had been seriously damaged in the flood, was repaired, and another one, 12 feet wide, with side slopes 1 on 1, was built at the opposite end. The dam in its present condition, as reconstructed, is practically a combination rock-fill and earth embankment, having a masonry core-wall throughout, and is manifestly a safe and substantial structure. The dam was planned and built by A. M. Welles, C.E., of Denver, with Mr. Alfred P. Boller, M. Am. Soc. C. E., of New York, as consulting engineer.

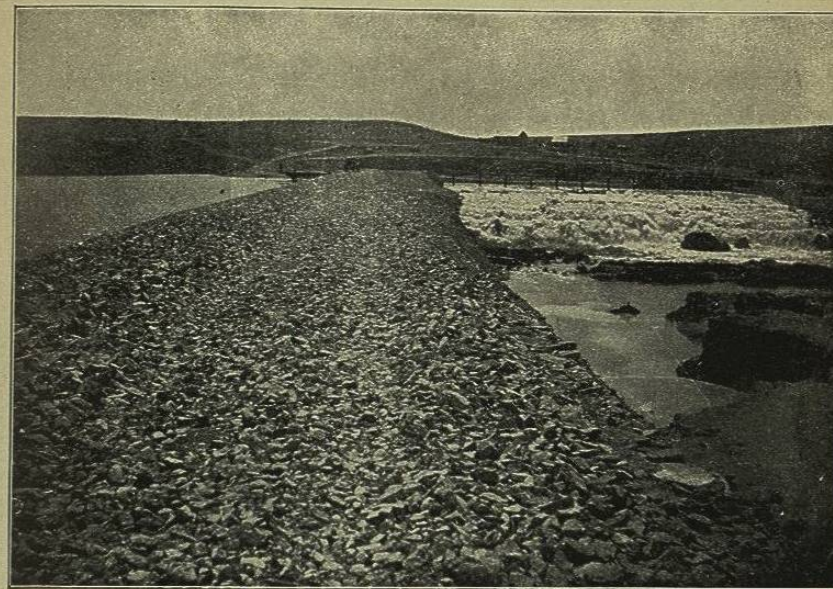
The dam was in service until August 3, 1893, when it was ruptured by a flood-wave that was in excess of the spillway capacity, the maximum flood discharge being 42,500 sec.-ft. The water poured over its crest, and, as this style of dam is not calculated to withstand such an overflow, it speedily washed out a breach to the bed-rock over 300 feet in length. This was immediately repaired and built 5 feet higher, at a total cost of \$86,000. The capacity of the open spillway at the west end of the dam was increased by widening it from 200 feet to a width of 240 feet, and by cutting it 3 feet deeper, making it begin to discharge while the water is 15 feet below the crest. A second spillway in rock was cut about half a mile to the west of spillway No. 1, having a length of 300 feet. In addition to these discharge-channels the main canal below the dam is so arranged that surplus water will begin to slop over its banks at a height of 13 feet above the bottom of the canal, over a length of about 200 feet. By opening the headgates and partially closing the secondary gates across the canal below, this slop-over can be given a large capacity of discharge. Ordinarily, however, the

FIG. 34.—LAKE AVALON DAM, PECOS RIVER, NEW MEXICO. SHOWING THE CREST OF COMPLETED DAM AND SPILLWAY DISCHARGING.

Mr. H. H. Cloud, formerly of the Colorado Midland Railroad, was the chief engineer of the dam, with Mr. E. S. Nettleton acting as consulting engineer, and Mr. Louis D. Blauvelt as principal assistant. Mr. Cloud ascribes the cause of the overtopping of the dam to the fact that the spillways were choked by the débris from bridges, together with the bodies of drowned cattle brought down by the river. Another account states that the gate-keeper and his assistants were in Eddy at the time, indulging in a drunken spree, and did not start for the dam until the only bridges across

the river were washed away, and they could not cross. When they finally secured boats for crossing and reached the dam just before the disaster, they were unable to open the waste-gates because of a defect in construction, since remedied. It was believed that if the lateral waste-gates along the canal had been opened when the flood-wave first reached the dam, the relief thus afforded would have avoided the disaster. No loss of life was reported as a result of the flood, and but little property was damaged.

hammer upon a latch-releasing bar at each gate, when the pressure forces them to fly open like a door. The opening can be closed above the gates by flash-boards, permitting the closing and latching of the doors. (See Fig. 36, taken from *Engineering News*, Sept. 17, 1896.) The total capacity which the spillways now have is estimated at 33,000 second-feet, while the water-level is still below the top of the dam.

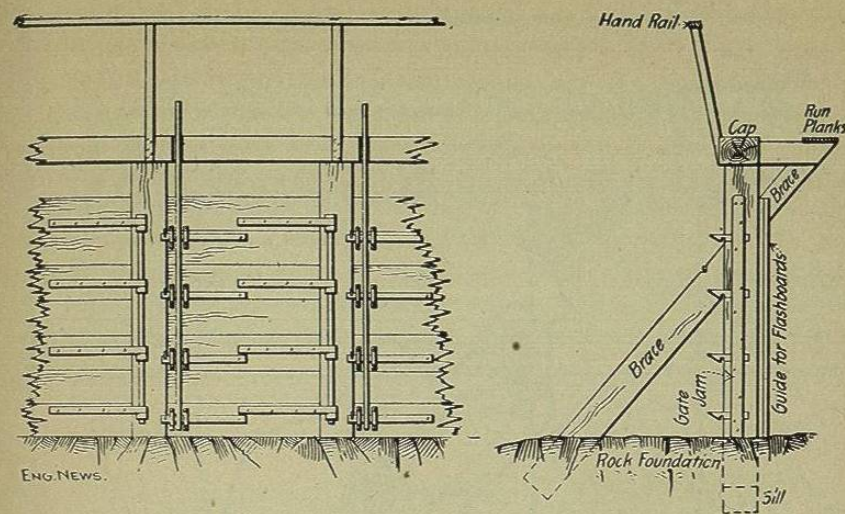
FIG. 36.—QUICK-OPENING GATES IN SPILLWAY OF LAKE AVALON RESERVOIR, PECOS VALLEY, N. M.

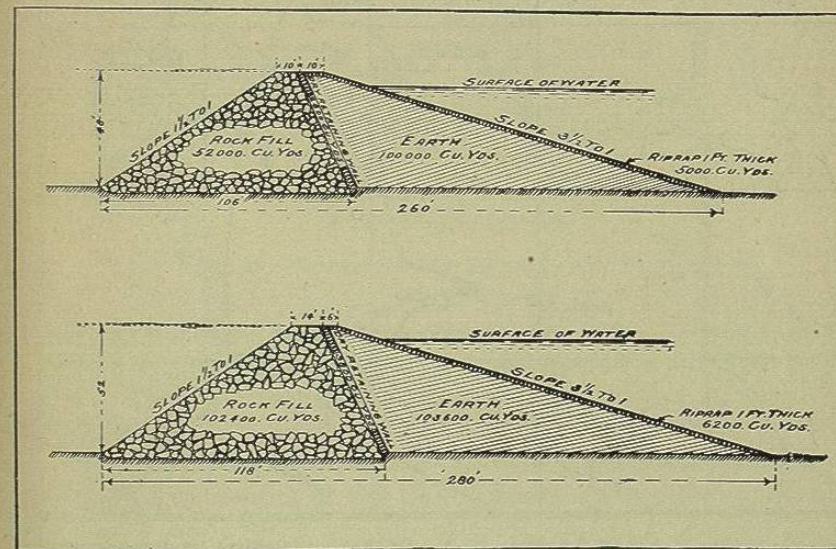
FIG. 37.—SECTIONS OF LAKE AVALON AND LAKE McMILLAN ROCK-FILL AND EARTH DAMS, PECOS VALLEY, N. M.

This leakage did not apparently affect the stability of the dams, although it may have been the contributing cause of the second failure of Lake Avalon dam, which occurred at 11 p.m., Oct. 1, 1904. An account of this failure, prepared by E. C. Murphy, Assoc. M. Soc. C. E., for *Engineering News* (July 6, 1905), states that the dam failed by the water forcing a passage through the dam, and not by flowing over the top. He says: "There are two opinions as to the cause of the failure. One is that animals burrowed into the earth part of the down-stream side and

weakened the earth facing; the other is the failure occurred near the base at the right back, due to a faulty connection of the dam with the bank." The flood discharge at the time was estimated at 82,000 cubic feet per second.

After the partial destruction of the dam the entire irrigation project passed into the control of the United States Reclamation Service, and the Avalon dam, which was an indispensable link in the system, was reconstructed on the plans and under the supervision of Mr. B. M. Hall, M. Am. Soc. C. E., as engineer in charge. The old dam was increased in top width from 20 feet to 43 feet by a substantial addition to the earth-fill on the up-stream side, and a core-wall of concrete, heavily reinforced
