Lake Frances Hydraulic-fill Dam, California.—As an example of unusual difficulties and adverse conditions successfully overcome where other methods have failed, the repair and enlargement of the broken Lake Frances dam by the hydraulic method is perhaps the most conspicuous which could be selected.

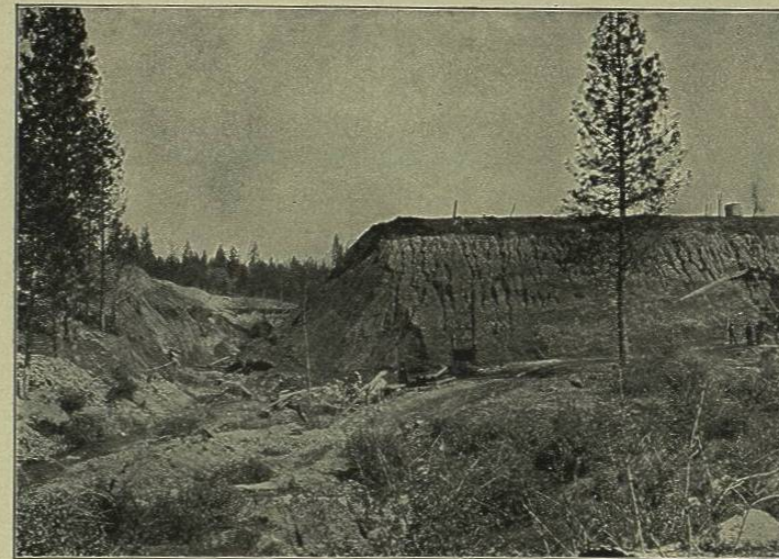
FIG. 84.—BREAK IN ORIGINAL LAKE FRANCES DAM. LOOKING UP STREAM.

in any way most convenient, as in an ordinary railway embankment, without any attempt at spreading in layers. The steep hill slope at the west end was not even cleared of stumps and roots over much of its surface, as the subsequent break revealed.

and when the water had risen to within six feet of the spillway level, at 11 A.M., Oct. 21, 1899, the dam was suddenly ruptured, and a hole washed through it 100 feet wide at top, extending down to and below the original stream-bed. The dam originally contained 80,265 cubic yards, of which 16,160 cubic yards, or about 20%, were washed away.

Repair and Enlargement by Hydraulic Method.—During the summer following the break the writer was employed to report on the repair of the broken dam, and after examination recommended that the hydraulic sluicing method be employed. In the spring of 1901 he was placed in charge of construction, associating with him Mr. J. M. Howells, M. Am. Soc. C. E., who corroborated the writer's recommendation of the hydraulic-sluicing process as the most desirable means for reconstruction. It was decided that it would be unwise to repair the dam

by simply filling the gap, as it would subject the remainder of the embankment, which had already failed at one point, to the possibility of a repetition of the same disaster, as well as subject the old and new parts to unequal settlement. It was therefore proposed to place a heavy layer of earth against the upper slope of the original fill of sufficient thickness to give an impervious core of selected fine clay between zones of porous, stable material. This added thickness was recommended to be 125 feet, measured horizontally, which, if carried out simply as a repair of the old dam, would have left it with a crest width of 141 feet. With this broad crest it was evidently safe to add 25 feet to the height

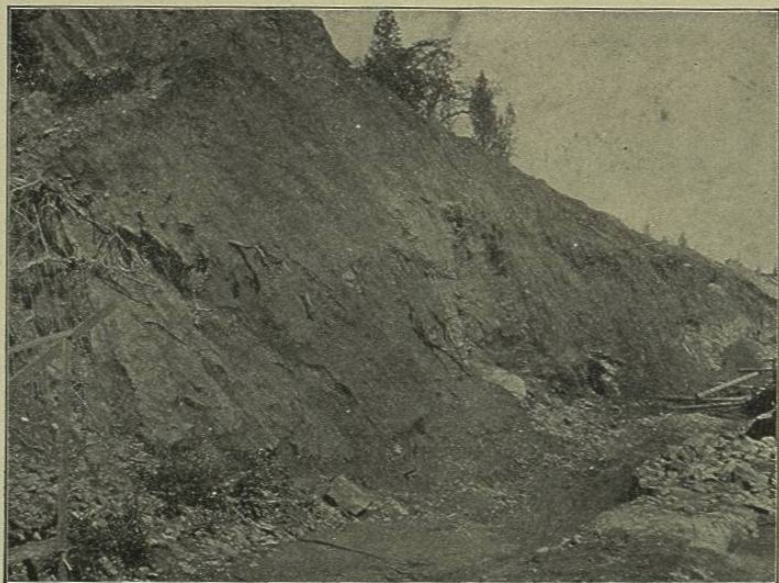
FIG. 85.—NEAR VIEW OF RIGHT SIDE OF BREAK IN EMBANKMENT OF LAKE FRANCES DAM SHOWING ROOTS EXPOSED BY THE BREAK.

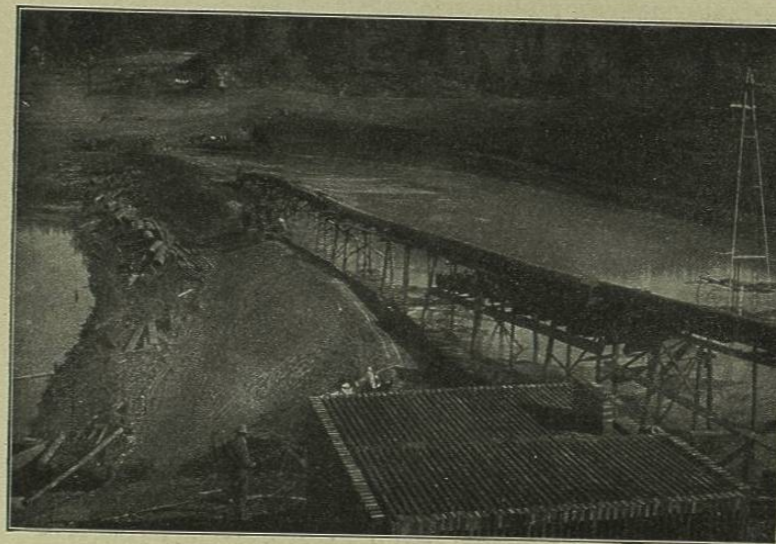
FIG. 86.—TOE LEVEL OF NORTH FACE, LAKE FRANCES DAM, AND INLET CRIB AT HEAD OF FIVE-FOOT OUTLET CULVERT.

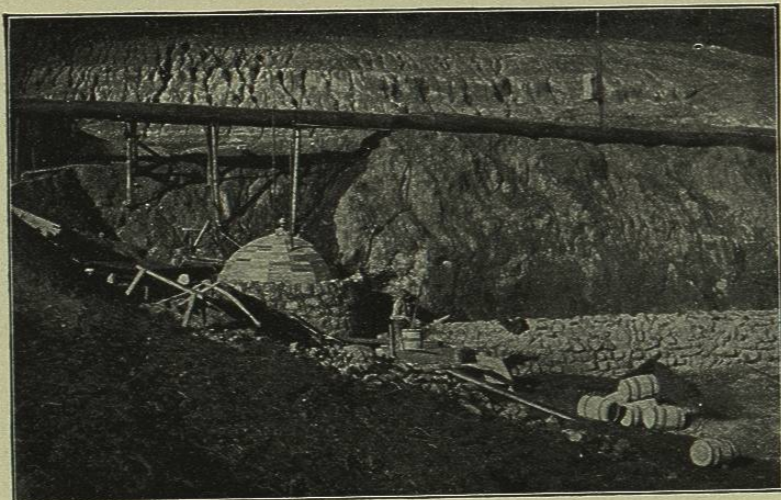
FIG. 87.—DOME ON GATE CHAMBER, LAKE FRANCES DAM; ALSO TWENTY-TWO-INCH SLUICE PIPE.

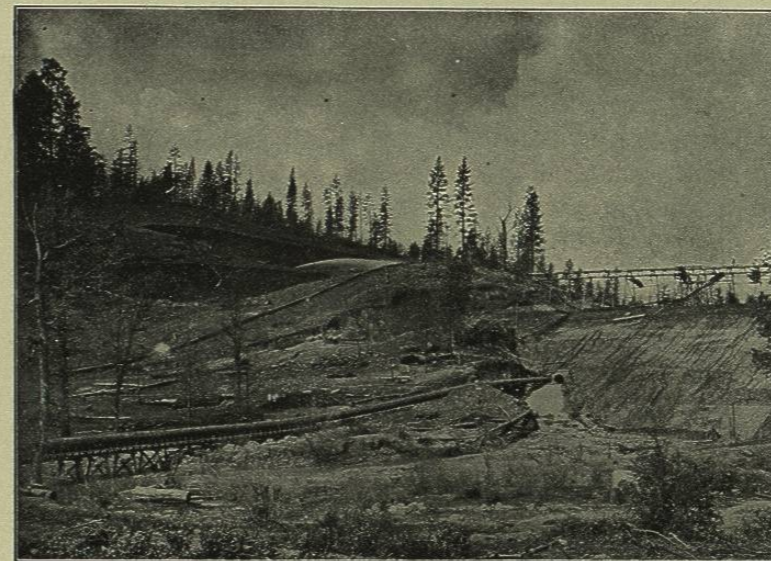
FIG. 88.—WEST END OF LAKE FRANCES DAM, SHOWING THE BREAK RESTORED, THE HIGHER DAM NEARLY COMPLETED, THE HYDRAULIC GIANT AT WORK, AND THE MAIN PIPE LINE SUPPLYING WATER TO THE PUMP.

The first work of the new plant was to complete the filling of the gap in the original dam by depositing the remaining 9620 cubic yards. This work was much hampered and delayed by the contracted area to which it was reduced, requiring frequent suspension of work to allow for proper settlement and drainage. Levees were maintained along the up-stream and down-stream slopes, one or two feet in height, composed

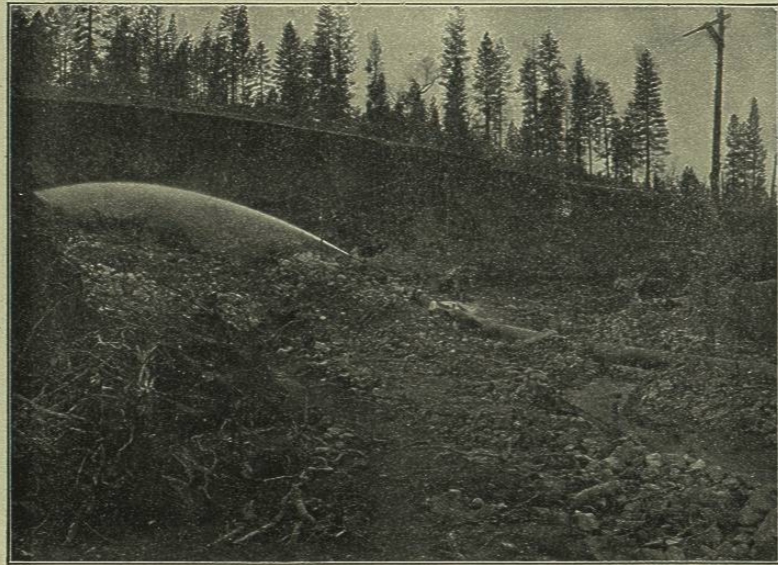
FIG. 89.—HYDRAULIC GIANT IN ACTION UNDERCUTTING THE BANK.

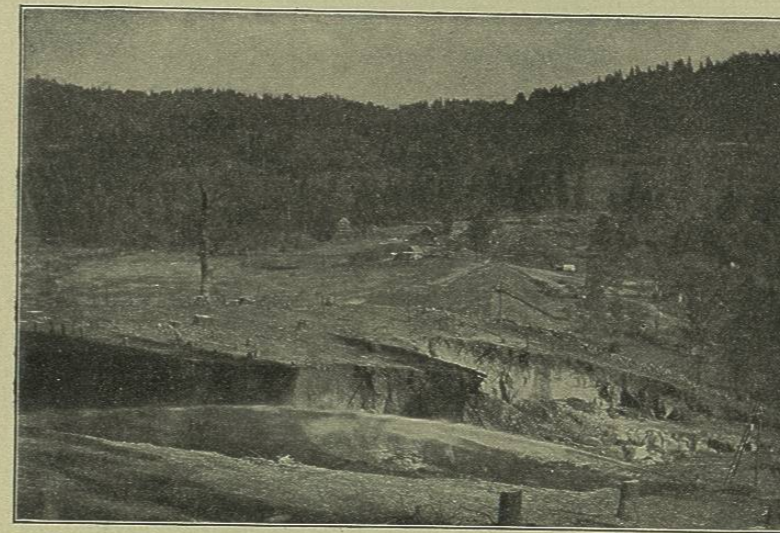
FIG. 90.—LAKE FRANCES DAM, NOVEMBER 6TH, 1901. FROM SOUTH BORROW-PIT, LOOKING ALONG AXIS OF ORIGINAL DAM.

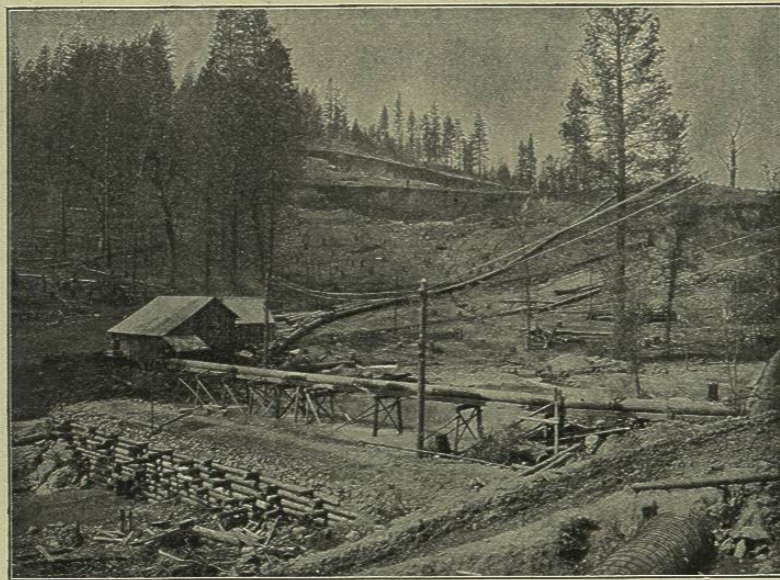
FIG. 91.—LAKE FRANCES DAM CONSTRUCTION. PUMPING STATION, SHOWING SUCTION PIPE CONNECTED TO TANDEM CENTRIFUGAL PUMP. CRIB DAM IN FOREGROUND BUILT TO STORE WATER FOR EARLIER OPERATIONS.

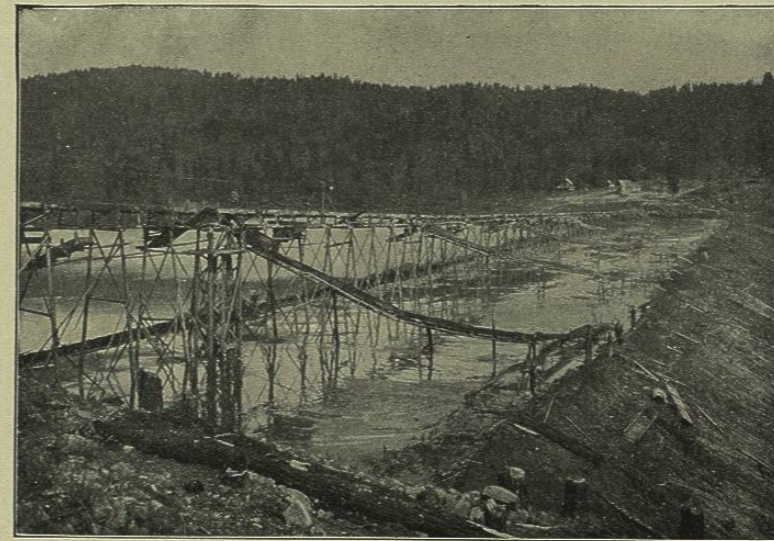
enough inside the slope lines to make delivery through lateral flumes of moderate length, terminating at the edges of the rising embankment. They were of varying length, according to the height at which they were designed to deliver, and were made about 25 feet in average height. The longest trestle with which the additional height of 25 feet above the original dam was built was 1560 feet long, with 13 branch trestles, as shown in Fig. 92. The highest bent in this trestle was 40 feet high.

FIG. 92.—LAKE FRANCES, CAL., HYDRAULIC-FILL DAM BUILDING. SHOWING OUTER LEVEES MAINTAINED WITH BRUSH, DEFLECTING BOARDS FOR DISTRIBUTING SLUICINGS ALONG SLOPE, GENTLE SLOPES TOWARD CENTER OF DAM, AND GRADUAL MOVEMENT OF DRAINAGE TOWARD EXTREME END.

the slopes, and prevent slides. It was finally found necessary to resort to the use of pine and cedar boughs and other brush 6 or 8 feet long laid into the slopes with the butts inside, to prevent the tendency to slip. This was effectual in knitting the mass together sufficiently to overcome the sliding and sloughing tendency.
