FIG. 156.—SWEETWATER (CAL.) MASONRY DAM.

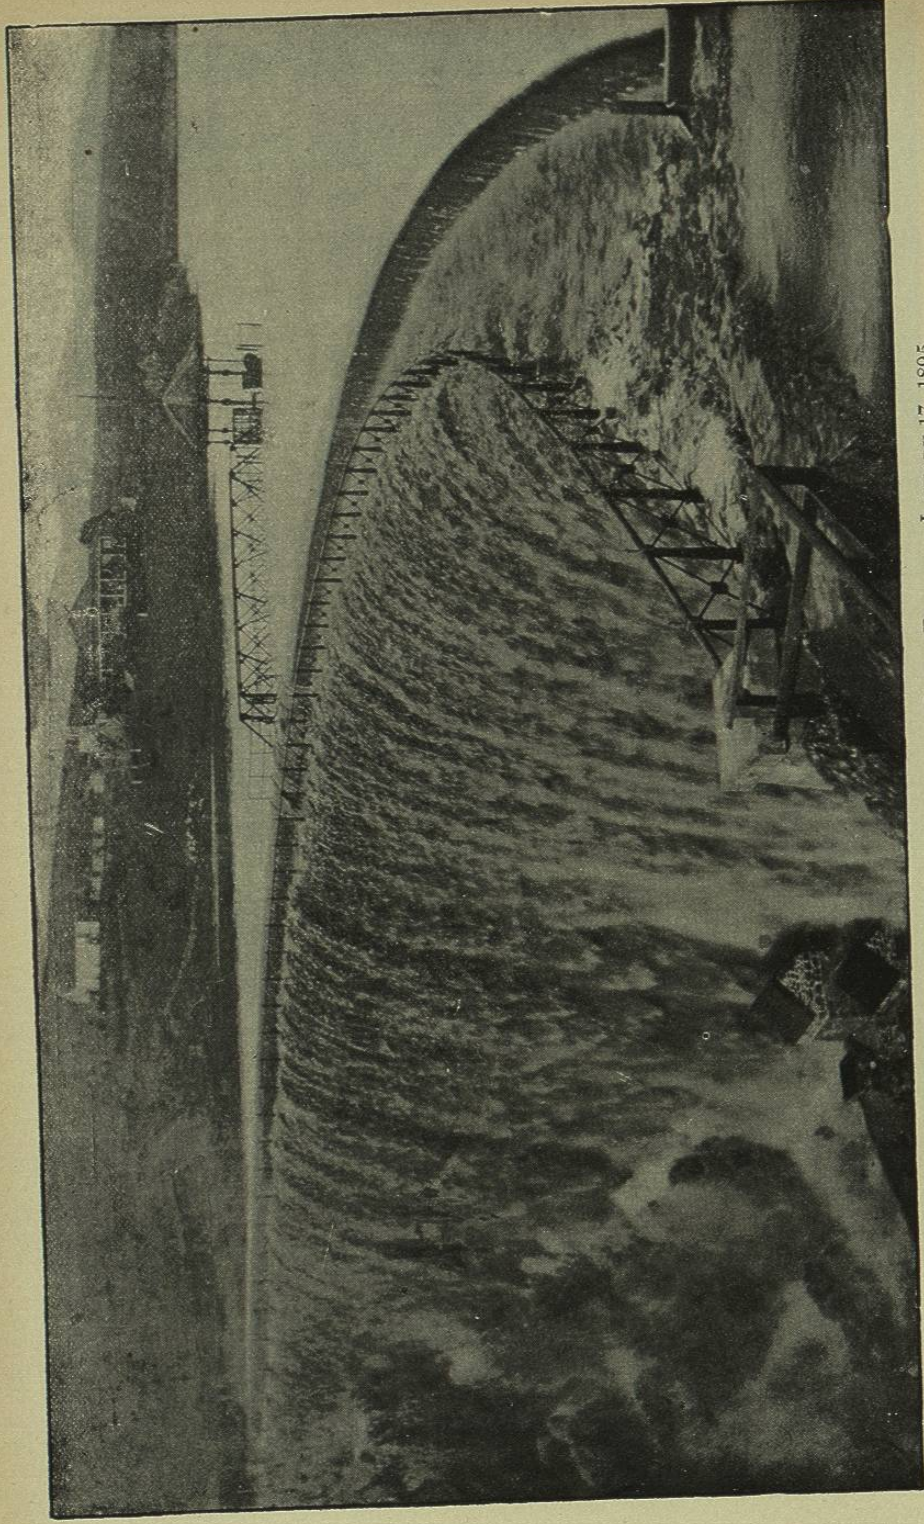
FIG. 155.—SWEETWATER DAM DURING THE GREAT FLOOD OF JANUARY 17, 1895.

*Enlargement.*—On the 17th and 18th of January, 1895, the Sweetwater dam successfully withstood a test far more severe than is usually imposed on reservoir walls of such comparatively slender dimensions (thanks to the painstaking care exercised in its original construction), and beyond any previous calculation or expectation. On those dates the reservoir was filled to overflowing by a flood resulting from a rainfall of more than 6 inches in 24 hours, and for forty hours the dam was submerged to a maximum depth of 22 inches over the parapet wall, with the wasteway and blow-off gate wide open. This was 5.5 feet higher than the water had been expected to rise in extreme floods, as it had not been considered possible for the crest of the parapet to be reached.

A gap in the ridge to the south of the reservoir, the crest of which was about level with the parapet, carried off quite a large additional volume at the extreme of the flood. The maximum rate of discharge during the flood was carefully computed by Mr. H. N. Savage from weir measurement, and found to be 18,150 second-feet, a rate of discharge which was maintained for one hour.

This extraordinary freshet, which within a week produced a run-off of nearly three times the capacity of the reservoir, was gratifying in one respect, in that it demonstrated the ability of the dam to cope with such emergencies, as not a stone of the masonry was disturbed or moved from place, although so much damage was done to the pipes and surroundings of the dam as to necessitate a large expenditure in repairs. The water-supply was cut off from consumers for more than a month before a partial restoration could be made.

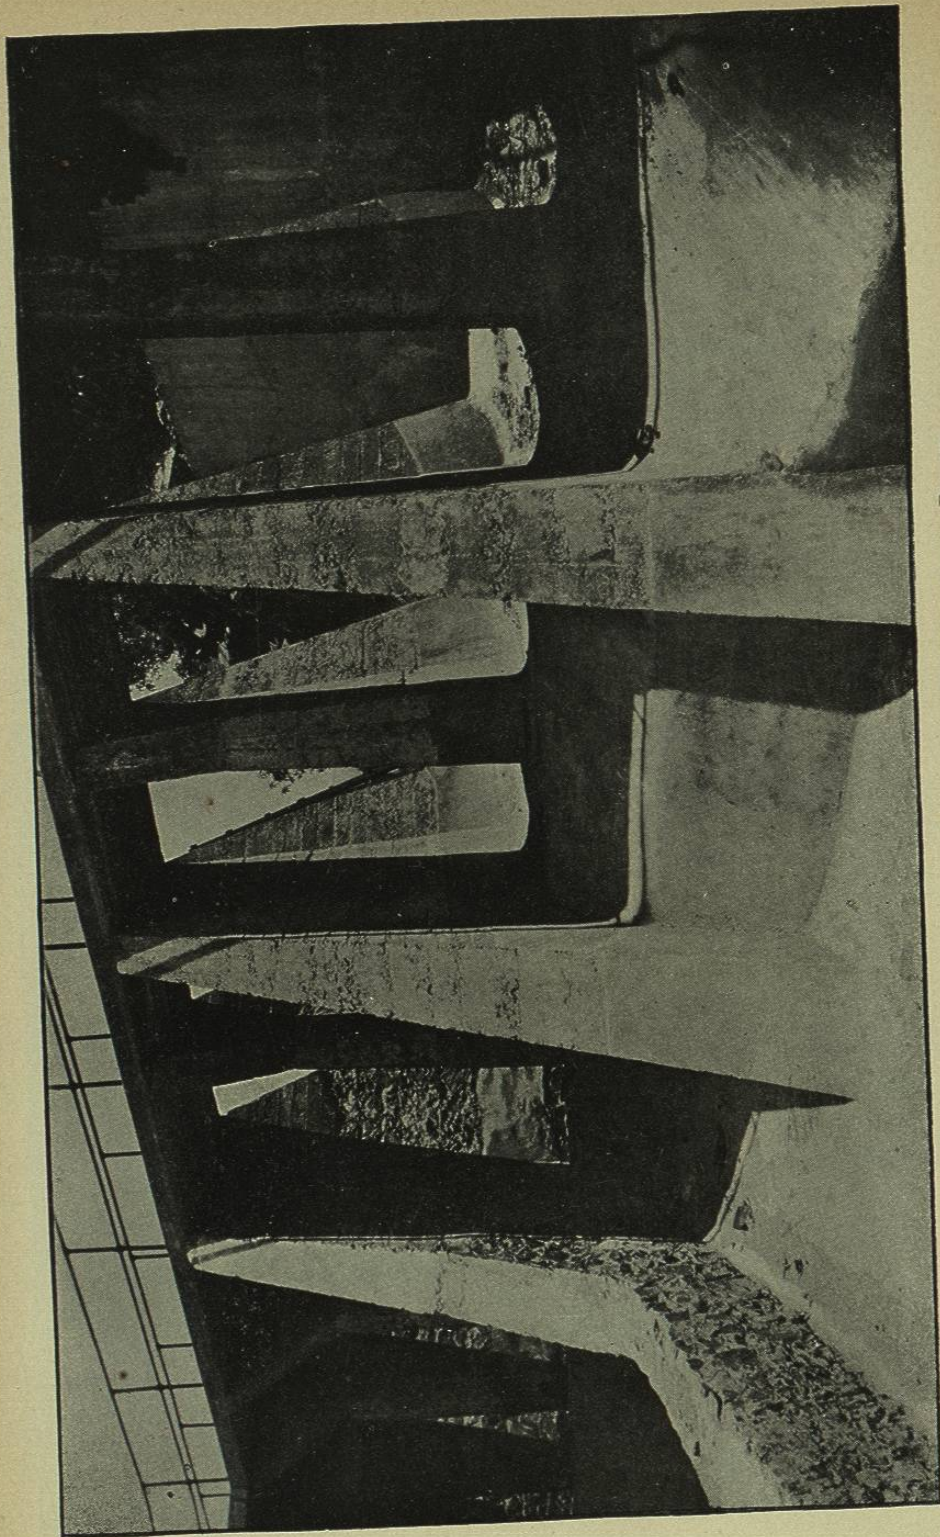
FIG. 157.—SPILLWAY OF SWEETWATER DAM, SEEN FROM BELOW.

1. The parapet of the dam was raised 2 feet and strengthened, so as to permit of permanently holding the water in the reservoir as high as its crest, leaving 200 feet in the center as a weir, 2 feet deep. This weir was arranged with cast-iron frames carrying flashboards, to be removed in extreme floods, as shown in Fig. 157.

2. The spillway was extended in length by adding four more bays, each 5 feet wide, and carrying all the bays up to the level of the new crest of the dam, giving it a maximum depth of 11.2 feet and a discharging capacity of 5500 second feet.

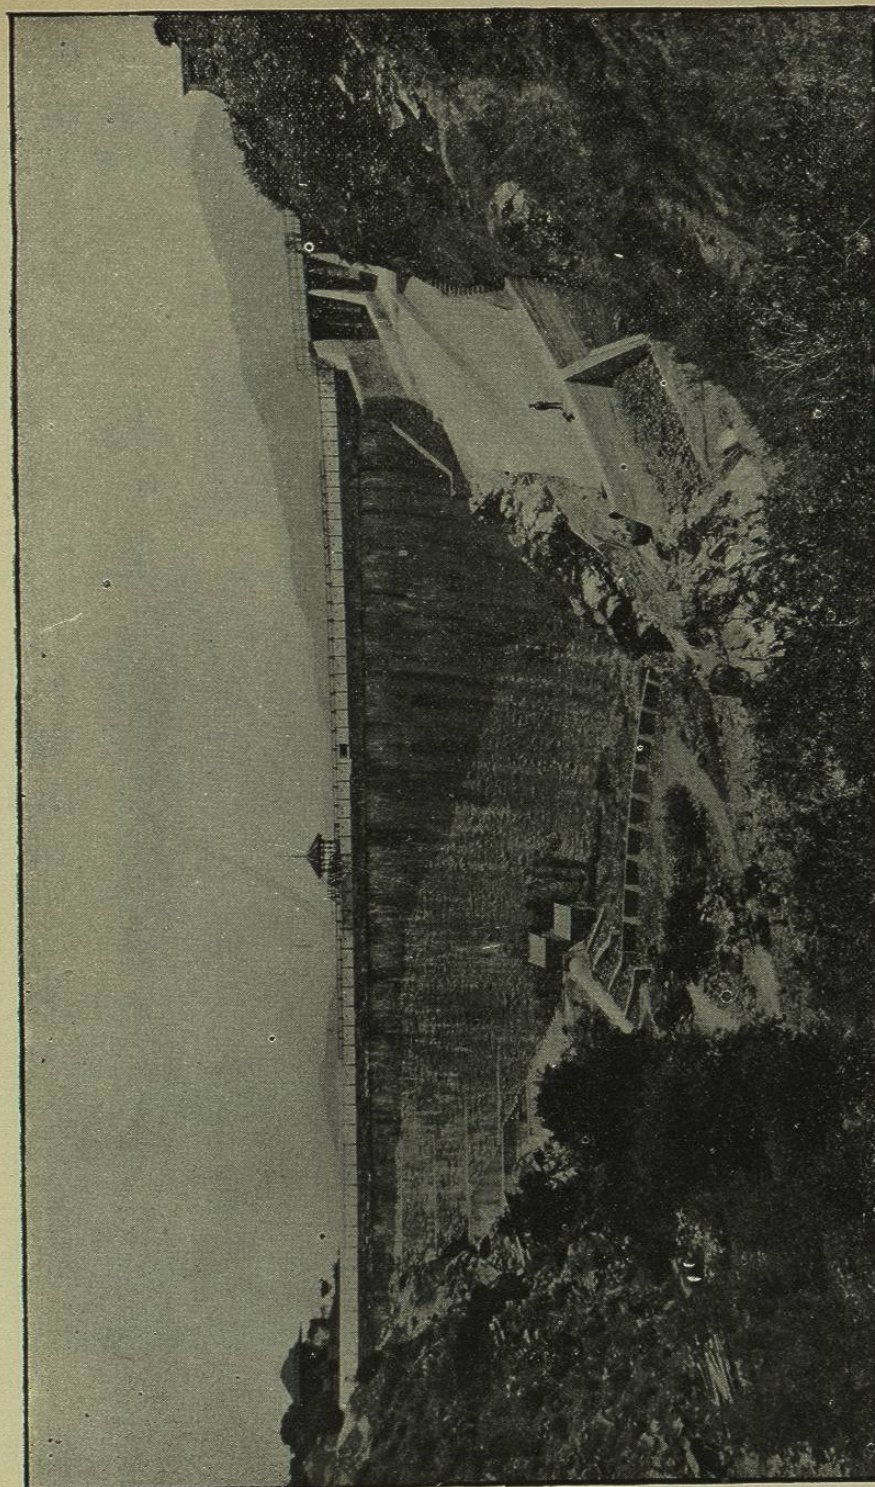
The freshet caused a tremendous erosion of the bed-rock on either side of the dam, particularly in front of the spillway discharge, where the strata were inclined at about the proper angle to enable the water to strip off layer after layer with surprising rapidity. It was estimated that no less than 10,000 cubic yards of the solid rock on that side were torn away and washed down-stream, and some 2000 yards from the opposite wall of the canyon. The approach of a disused tunnel below the spillway, which was some 25 feet long, and about 30 feet of the tunnel itself, in solid rock, were cut off and the surrounding rock washed away. This tunnel had been opened some years before to draw down the reservoir, in compliance with the order of the United States Circuit Court, in the famous litigation over the condemnation of lands in the reservoir-basin, and terminated directly in front of the spillway channel. The bombardment of the stones rolled down the canyon during the flood upon the pipeline resting on one side and covered with masonry, destroyed it for a considerable distance down-stream, as well as the railway track leading to the dam.

FIG. 158.—SWEETWATER DAM, SHOWING NEW APRON OF SPILLWAY AND PROTECTING SPIR-WALLS ON PIPE-LINE.

4. The eroded rock slope below the wasteway after being made uniform was covered with a grillage of iron rails embedded in concrete, which has a

thickness of 3 feet, and is designed to prevent all future erosion of the bed-rock (Figs. 158 and 162).

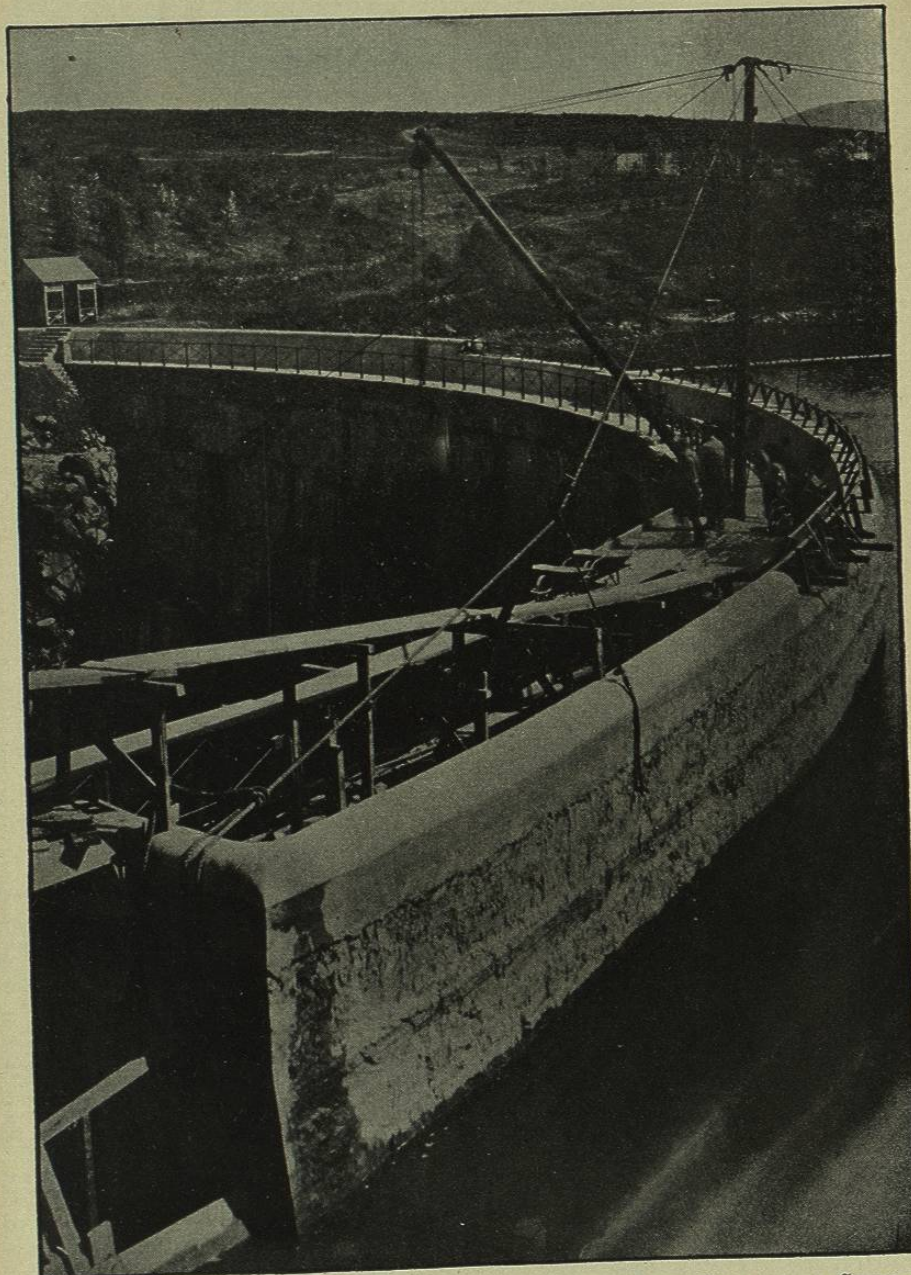
FIG. 159.—REPAIRING AND INCREASING THE HEIGHT OF THE PARAPET OF SWEETWATER DAM.

The effect of raising the parapet wall in the manner described has been to raise the height of the reservoir 5.5 feet and increase its capacity about 25%, or from 18,053 acre-feet to 22,566 acre-feet. The dam having shown its ability to withstand this increased pressure, it is now proposed to make this addition to the reservoir a permanent feature of the works.

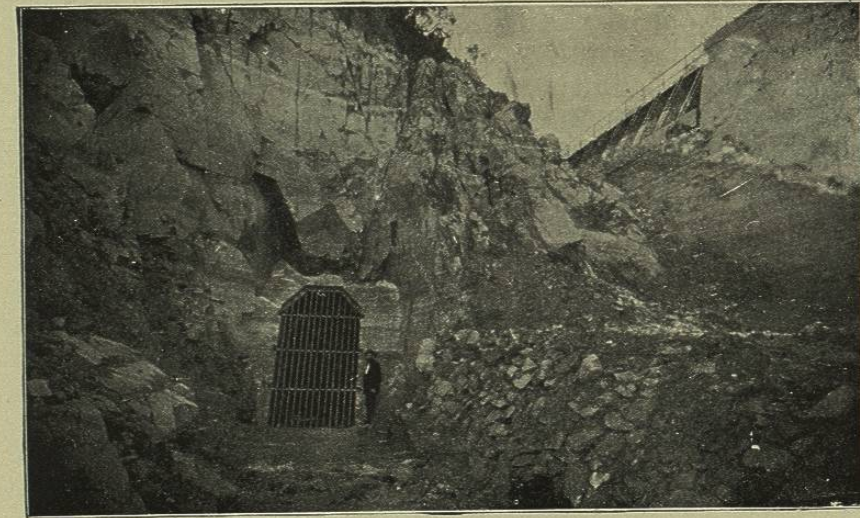
FIG. 163.—SWEETWATER DAM, SHOWING HEAD OF OUTLET TUNNEL AND SPILLWAY.

3. The unused tunnel, 8 by 12 feet in size, the bottom of which at the head is 50 feet below high-water mark, was adapted for use as an additional spillway discharge, by laying four pipes through it on a 4% grade, two of which are 36 inches and two 30 inches in diameter, all arranged with valve covers over elbows at their upper ends, where a shaft, reaching to the surface on the line of the dam, gives means of control (see Figs. 159, 160, and 161). Further control is had by gate-valves set in the pipes directly below the masonry bulkhead built across the tunnel at the shaft, all the pipes passing through this bulkhead. In the summer of 1899, when the reservoir was empty, the head of this tunnel was protected by a concrete portal with an inclined grillage of iron rails to keep out drift, as shown in Fig. 161.
