PLATE III.

PLATE IV.

PLATE V.

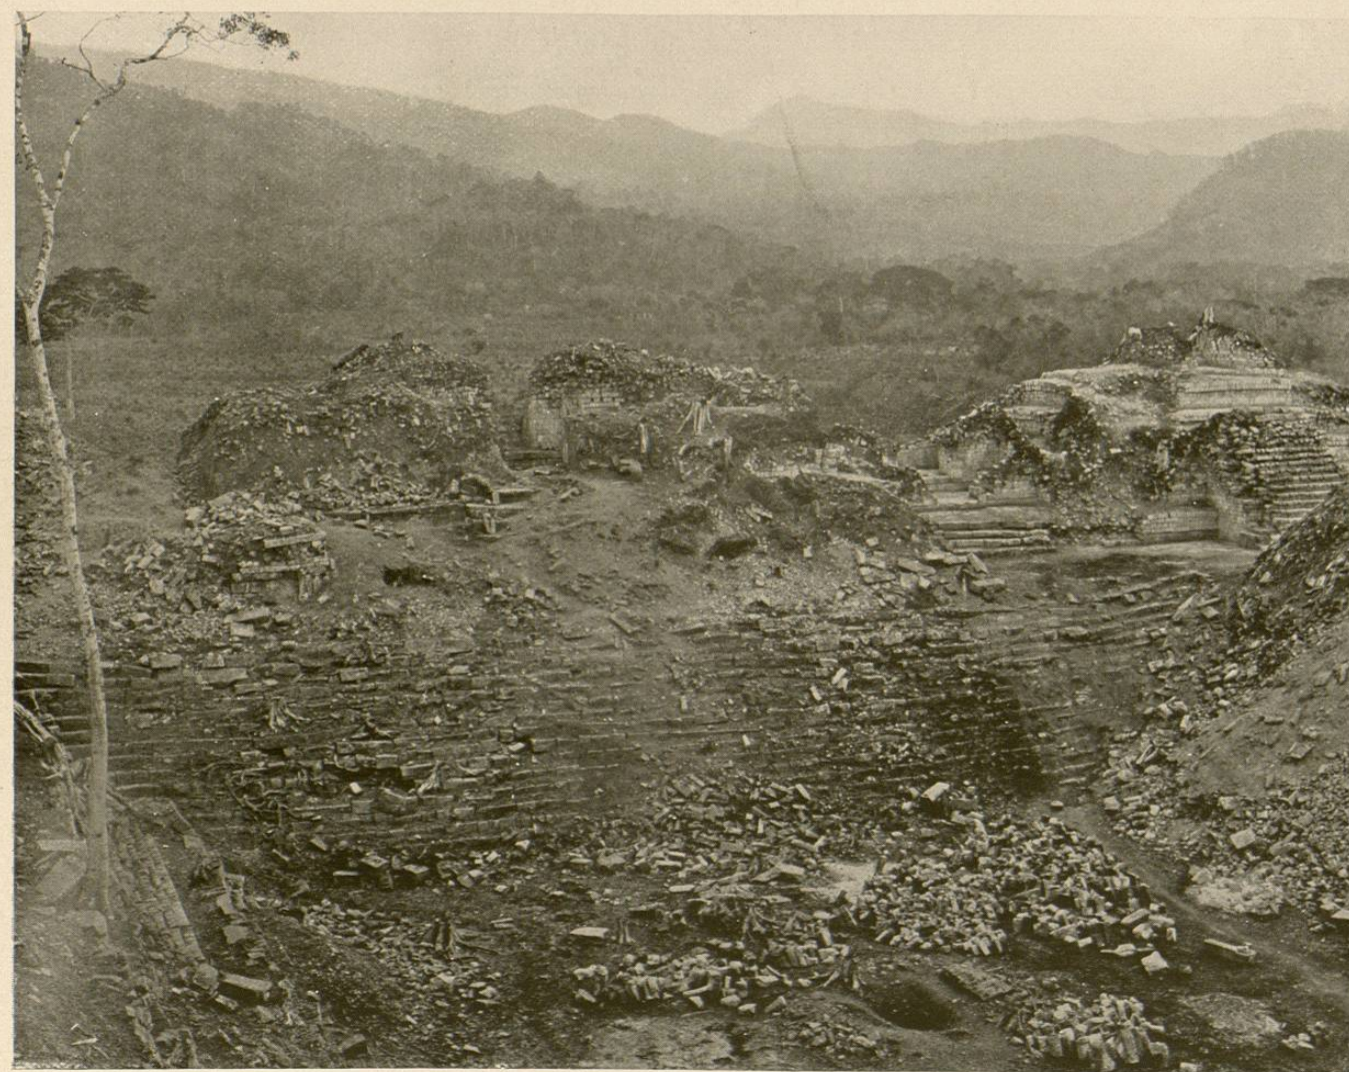
FIG. 2. From summit of Pyramid 16, looking northeast. A portion of Eastern Court is seen with the northern flight of steps leading up to Temples 21, 21a, and 22. The northern end of the eastern flight of steps is covered by the debris from Mound 20 at the extreme right. The Jaguar steps (23) are at the left in the foreground. Mound 21 with its ruined temple is shown at the right above the flight of steps. Mound 22 at the left. Temple 21a occupies the space between 21 and 22. (Pages 17-19. See also Plate II. 2, and Plate IV. 1.)

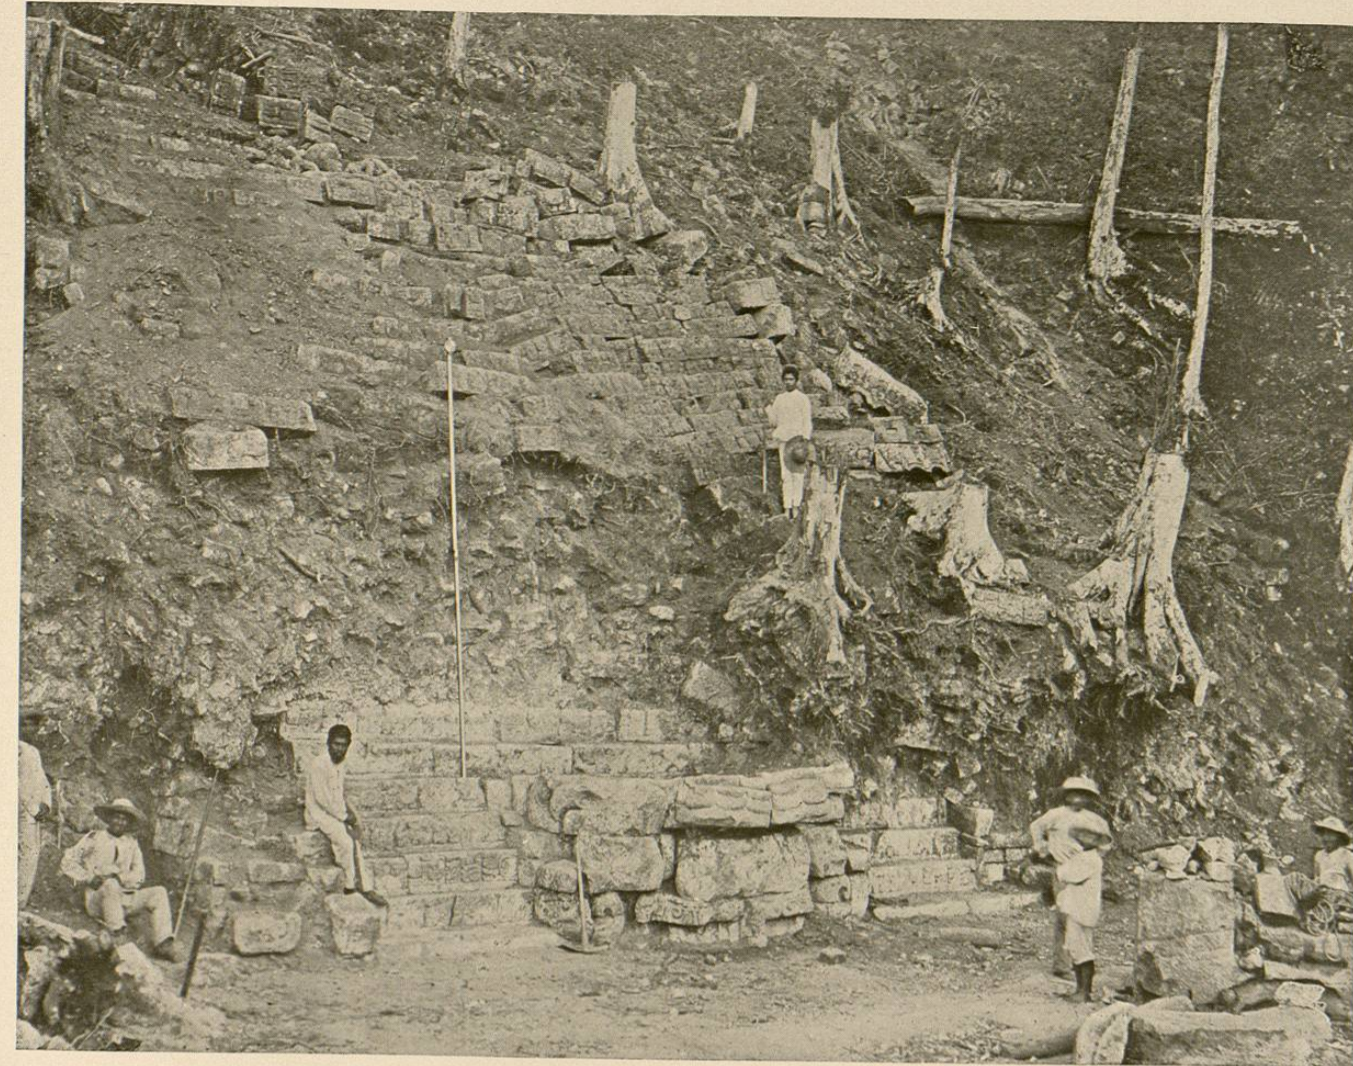
FIG. 1. A portion of the Hieroglyphic Stairway with a pedestal at base. Western side of Mound 26. (Page 21.)

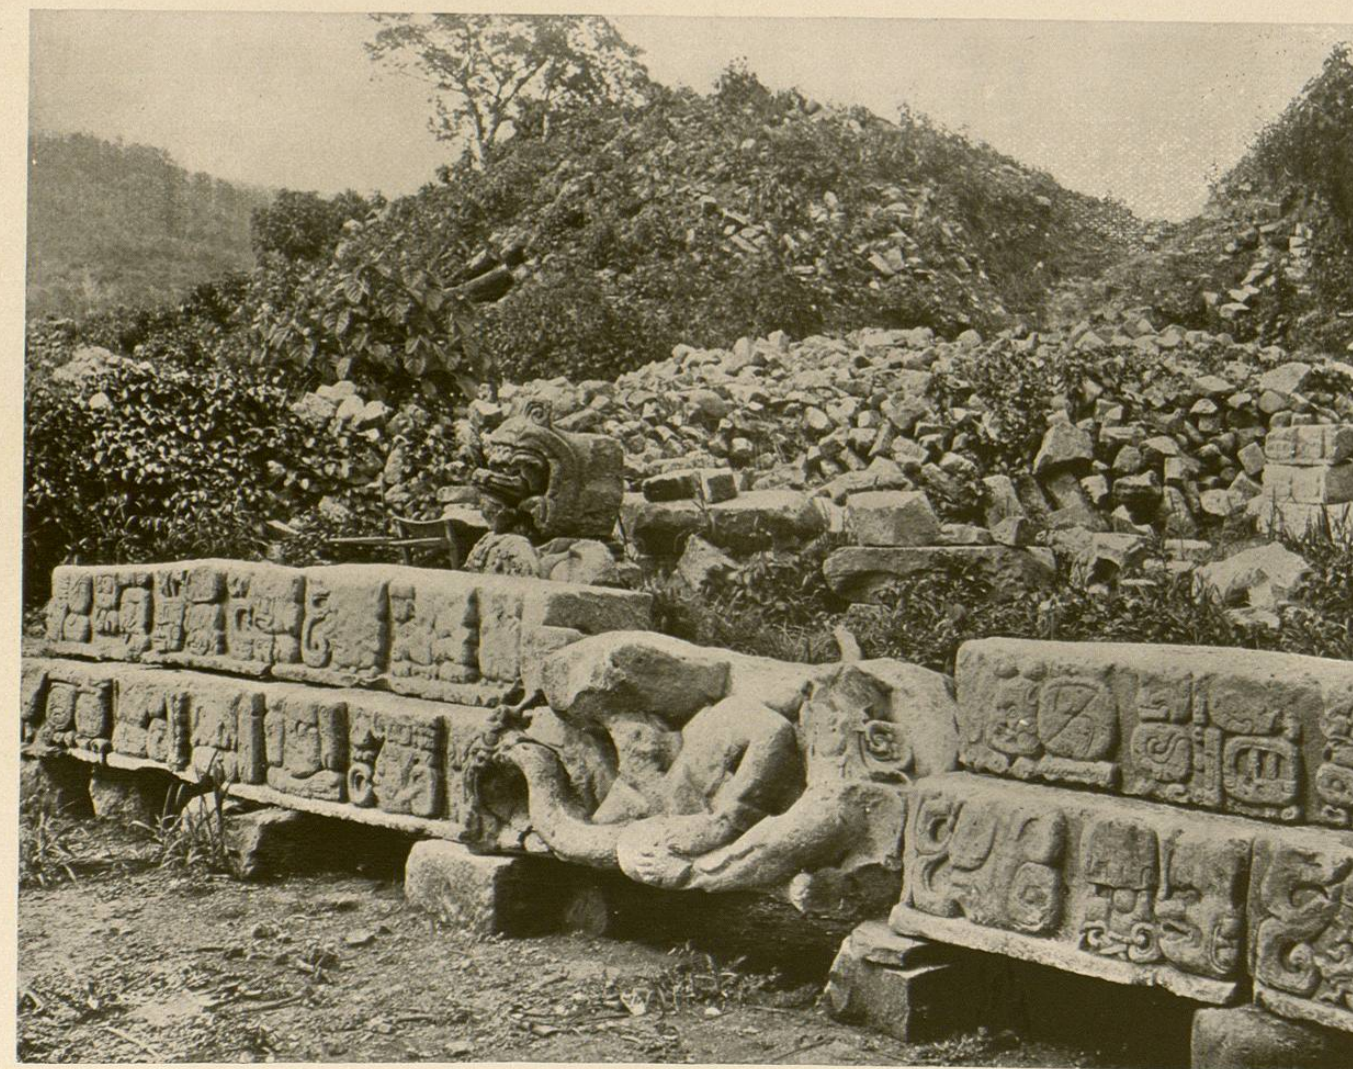
FIG. 2. Blocks from two steps of the Hieroglyphic Stairway, showing a broken sculpture representing a reclining human figure in central part of stairway. (Page 22.)
