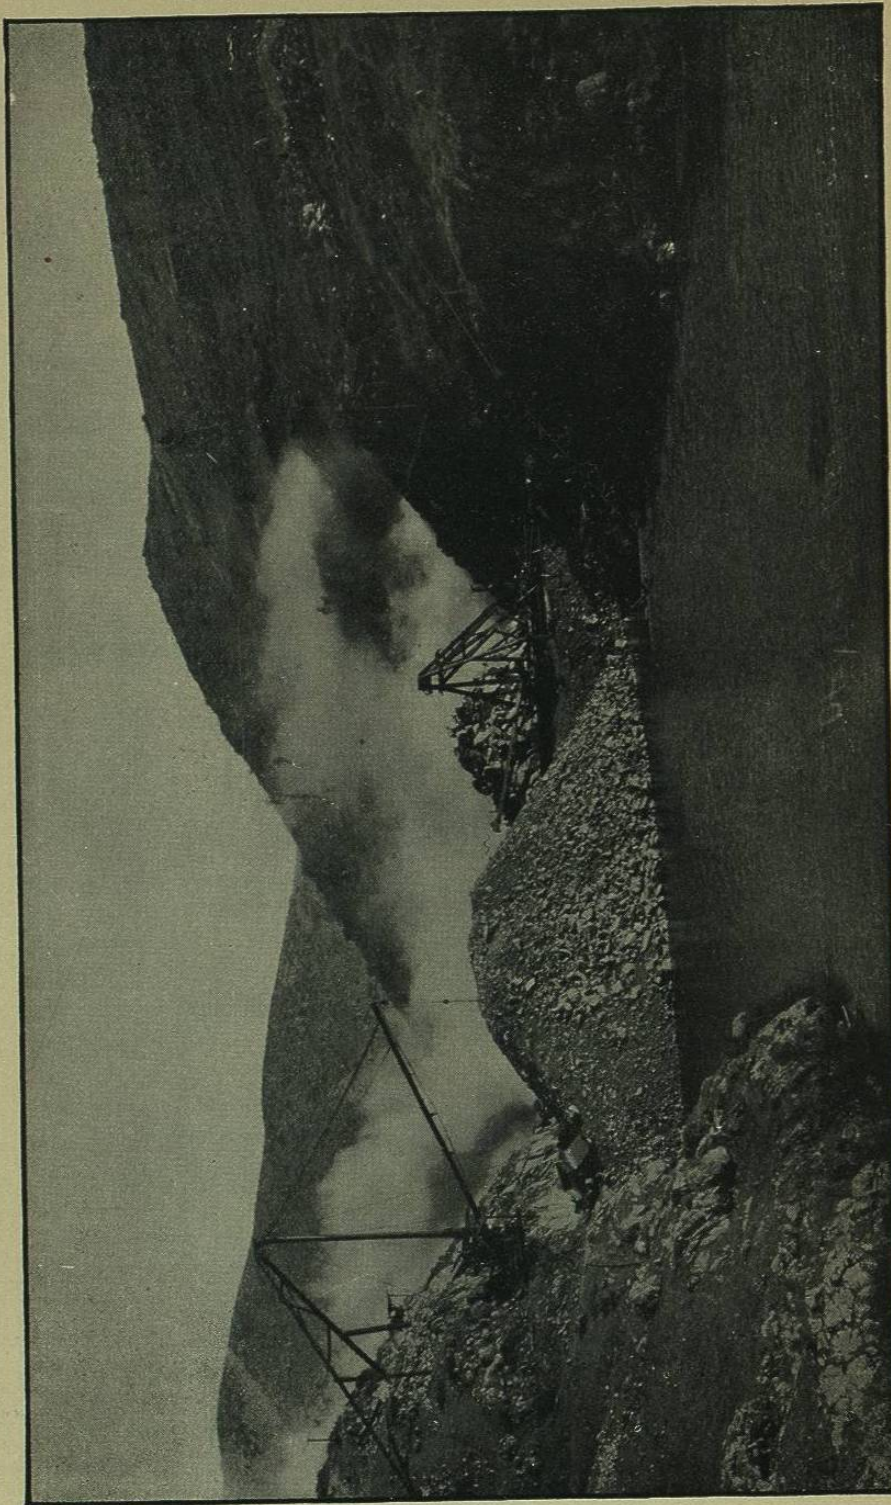
FIG. 19.—EXPLOSION OF GREAT BLAST AT LOWER OTAY ROCK-FILL DAM.
