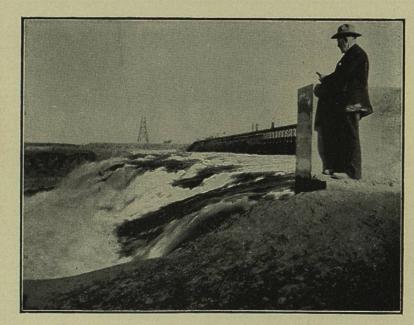
Fig. 48.—Milner Dam, Snake River, Idaho. Showing Waste-way Gates and Discharge of River Over "Irrigation Falls."

Figs. 47, 48, 49, 50, 51, and 52 illustrate the construction of these notable dams, and Fig. 53 shows the type of head-gates successfully

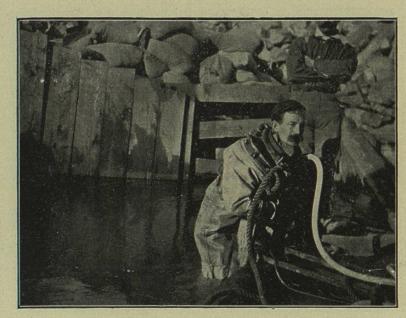
Fig. 50.—Milner Dam. Divers at Work Placing Sheet Piling in 40 Feet of Water
