FIG. 75.—CROSS-SECTION OF LA MESA DAM.

Crane Valley Hydraulic-fill Dam, California.—Some years ago the San Joaquin Electric Company erected a power-plant on the San Joaquin River, 34 miles north of Fresno, to utilize water brought from the North Fork of the San Joaquin to the power station. The power-drop at this place is 1410 feet, and the plant is remarkable as one of the first to make use of so high a drop, as well as for the long distance of the transmission of power, as the company deliver electricity to Hanford, a distance of 70 miles, as well

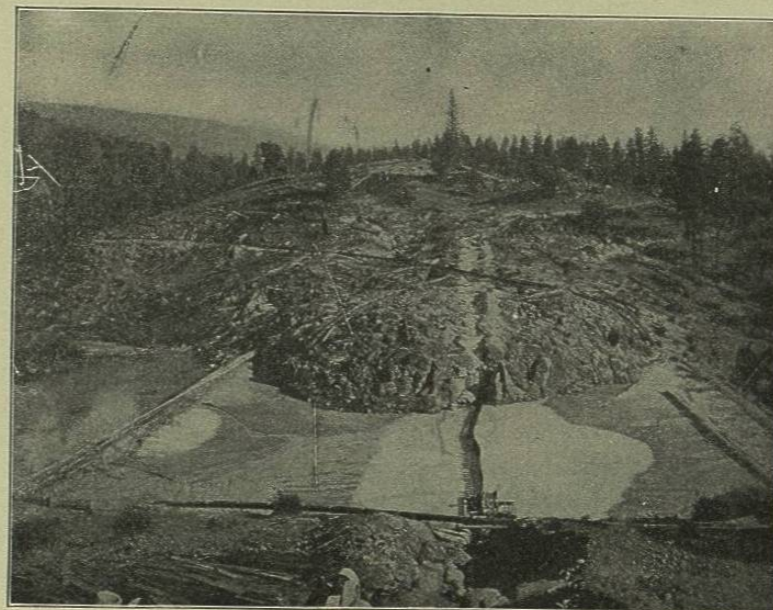
FIG. 79.—CRANE VALLEY DAM. SHOWING WOODEN FENCE, OR CENTER DIAPHRAGM, WHICH WAS CARRIED UP TO A HEIGHT OF 30 FEET ABOVE BED-ROCK.

1-inch surfaced sheeting. This wooden partition was continued to a height of some 30 feet above the base of the dam, its object being mainly to prevent the stratification of material deposited by the water from extending across the center of the dam from either side. It was also designed as a check against percolation through the dam.

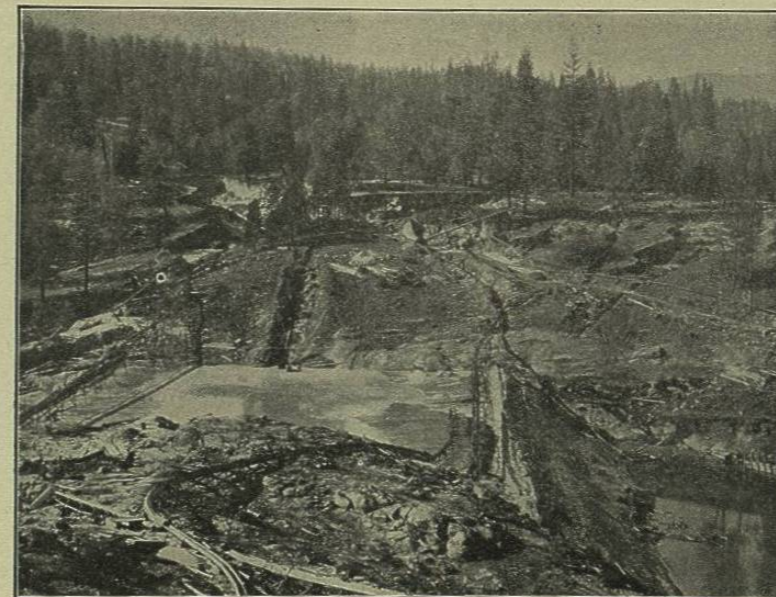
FIG. 82.—BORROW-PITS FROM WHICH MATERIAL WAS SLUICED TO THE CRANE VALLEY DAM IN BACKGROUND.
