Granite Springs Masonry Dam, Wyoming.—There are few dams in Western America more correctly representing the principles of modern science as applied to dam construction, and more generally satisfactory in economy of design and execution than the dam erected in 1903–04 by the City of Cheyenne, Wyoming, for the storage of a domestic water-supply at Granite Springs, on Middle Fork of Crow Creek, 12 miles from the city. The work was designed and built by A. J. Wiley, M. Am. Soc. C. E., to whom the author is indebted for the facts regarding the work, and the accompanying illustrations. (Figs. 232, 233, and 234.)

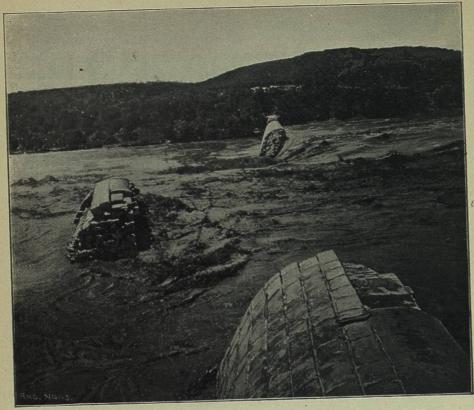
Fig. 230.—Austin Dam, Texas. View taken during Flood, a few Minutes

The appearance of the dam immediately before the break is shown in Fig. 229. Figs. 230 and 231 graphically present the break and the bodily movement of a section of the dam down-stream intact, better than any detailed description. The author is indebted to *Engineering News* for these three cuts.
