The Lake Frances Dam.—All of the photographs accompanying the description of the Lake Frances hydraulic-fill dam on pp. 115 to 125 were taken during construction and before its final completion. Fig. 349, however, is a recent view taken in 1907, showing the finished dam in service. In the foreground is seen a secondary spillway and controlling-gates, added since the dam was completed. This is a wooden flume, 16 feet wide; 6 feet deep below the water-line, the apparent object of which was to allow them to begin wasting water before the lake filled to its full depth at the main spillway level.

The Milner Dam, Idaho.—The photograph shown in Fig. 355 gives a more comprehensive picture of the three combination dams described on page 60 than any of the other illustrations accompanying the article (see Figs. 47 to 53), and will therefore add to the interest in these important and successful dams.

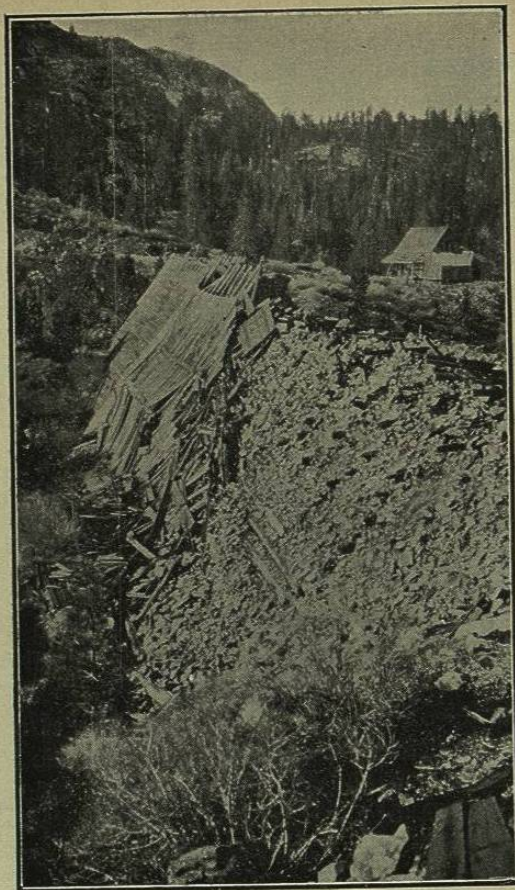
FIG. 346.—UP-STREAM FACE OF ONE OF THE TWO REMAINING ROCK-FILL STRUCTURES WHICH, WITH THE THIRD STRUCTURE DESTROYED IN 1883, ORIGINALLY FORMED THE ENGLISH LAKE DAM.

The existing dams both have a crest extension of wood, 6 feet high, of similar construction. (See Figs. 346 and 347.) This is also well illustrated by Fig. 348, showing the dry wall laid up on the down-stream face.

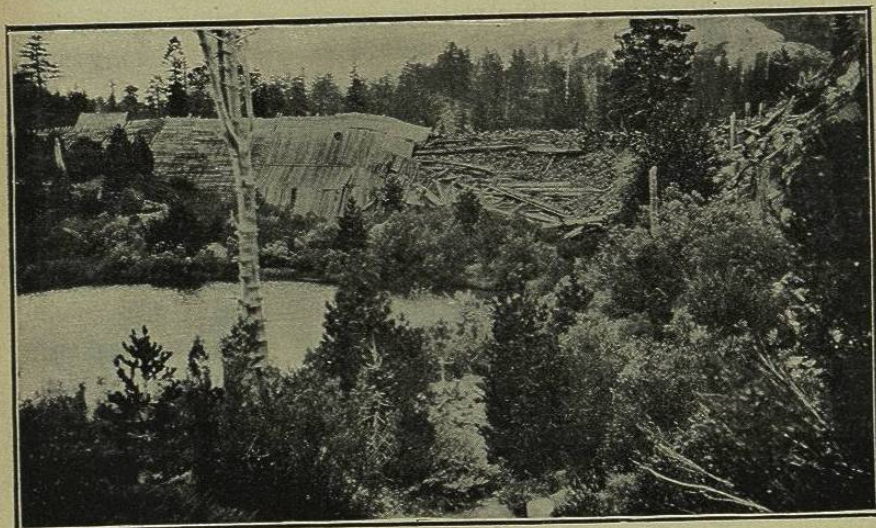
FIG. 347.—GENERAL VIEW OF THE TIMBER SKIN ON UP-STREAM SIDE OF THE ENGLISH LAKE DAM. NOW IN RUIN.
