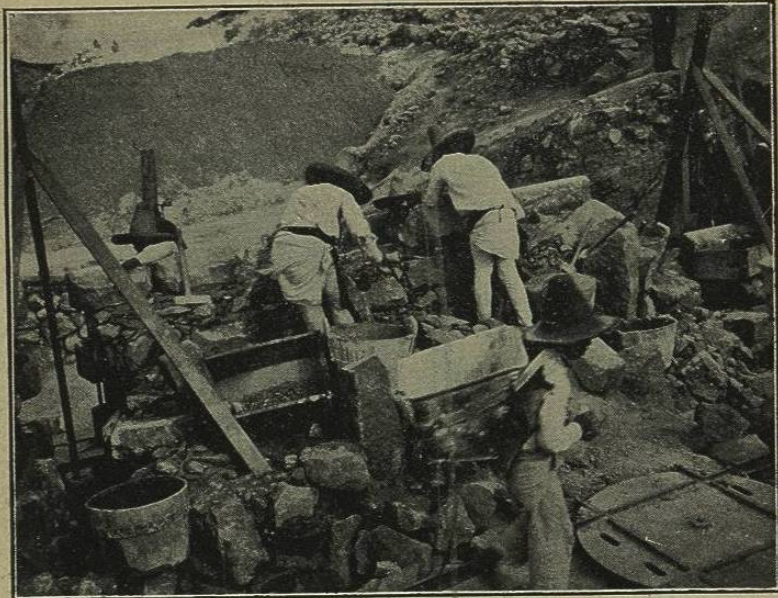
FIG. 374.—MASONS AT WORK ON THE SAN JOSÉ DAM, MEXICO.
